East Fork Hotel Creek

Table 16 Forest Cover Types and Structure by Cover Type in the Blue Creek Assessment Area

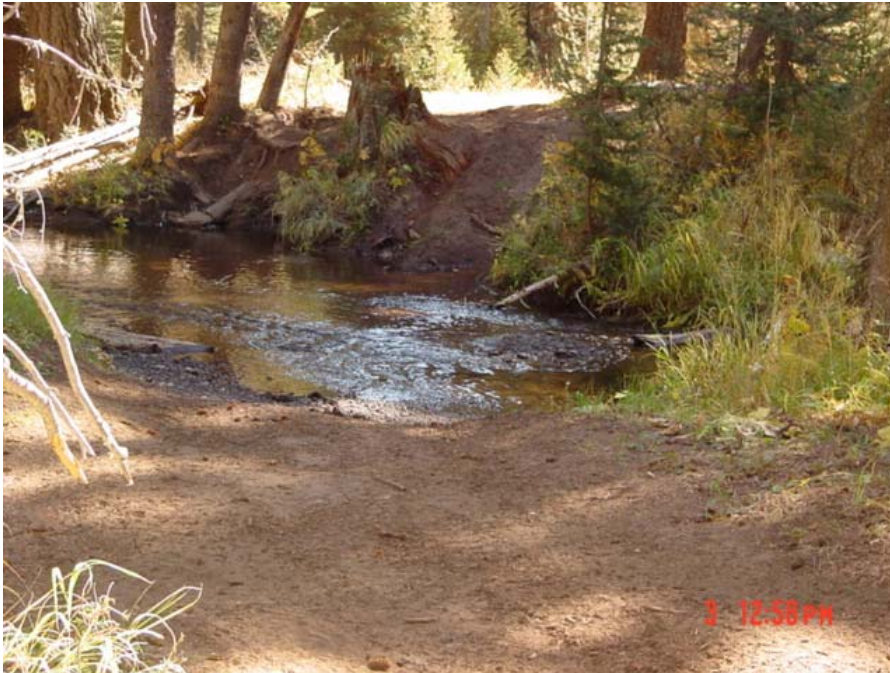
Figure 73 A four-wheeler crossing site near the Forest boundary. Four-wheelers have impacted the lower portions of the stream.

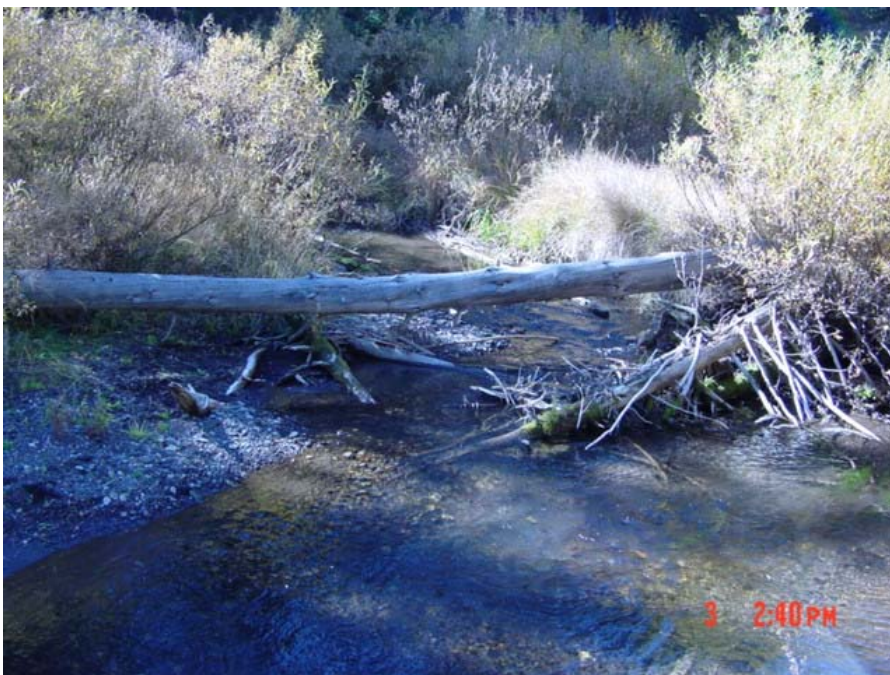
Figure 74 East Fork Hotel Creek

East Fork Hotel Creek near the Forest boundary in Section 36, Township 14 North, Range 42 East. Flow is about 1 cfs. Bankfull width is ~ 5 feet. Bankfull depth is ~ 1 foot. The channel has downcut several feet. There is a heavy sand/gravel bedload, with embeddedness nearly 100% in pools and over 50% in riffles.

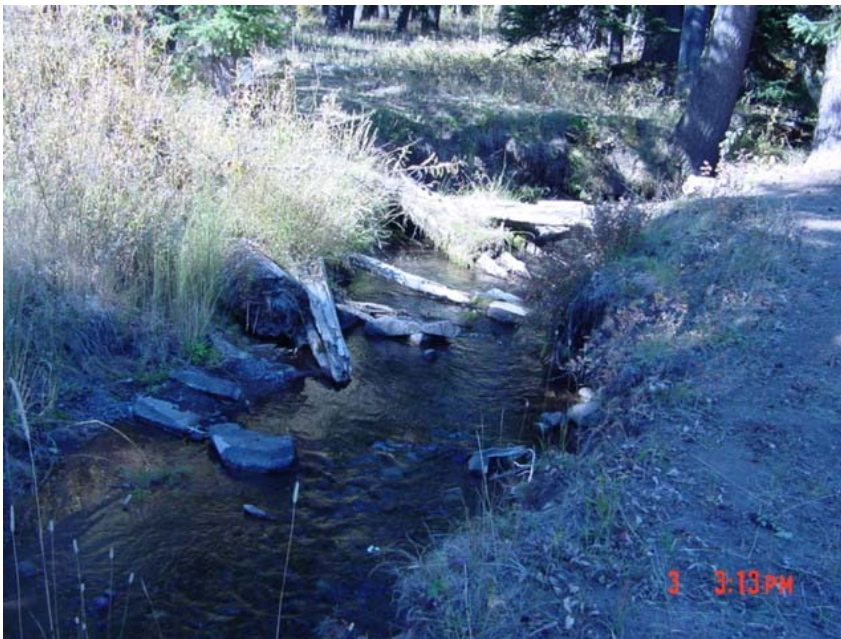
Figure 76 ATV crossing on west fork Hotel creek.

A make-shift bridge has been placed across the stream channel (Figure 76). The non-system trail parallels the stream for nearly a mile at the lower end of the reach

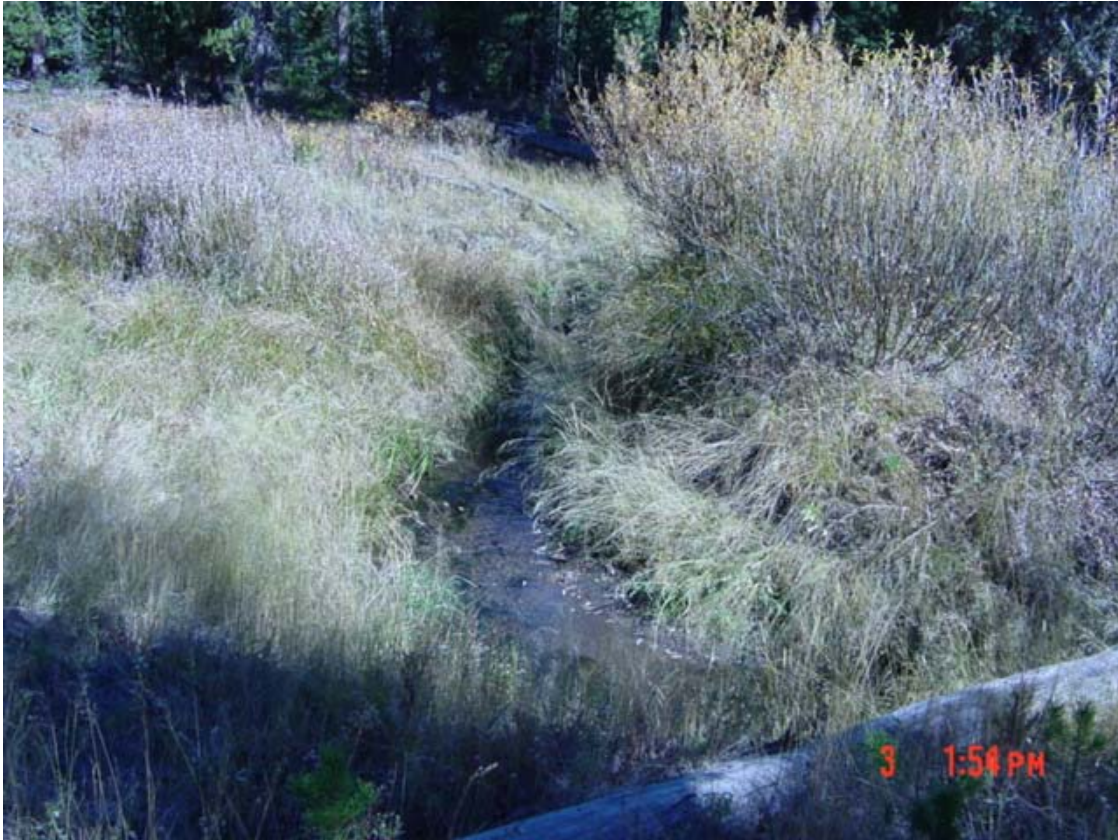
Figure 77 Hotel Creek

Hotel Creek about $\frac{1}{2}$ mile above the West Fork confluence. Bankfull width is ~ 4 feet. Bankfull depth is ~ 0.5 ft. Flow is about $\frac{1}{4}$ cfs. The channel type is primarily a C4, with inclusions of E4.

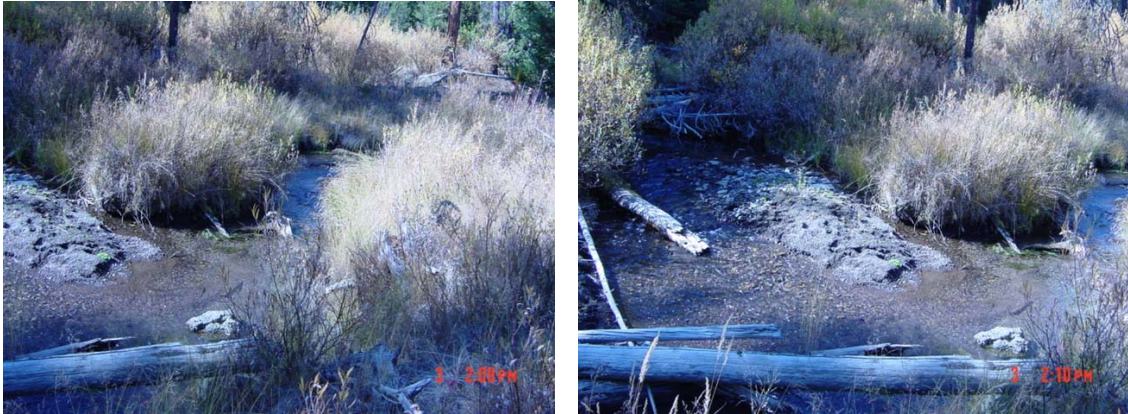
Figure 78 Hotel Creek at the West Fork confluence. Note the sand bar (left side of photo) being transported down West Fork.

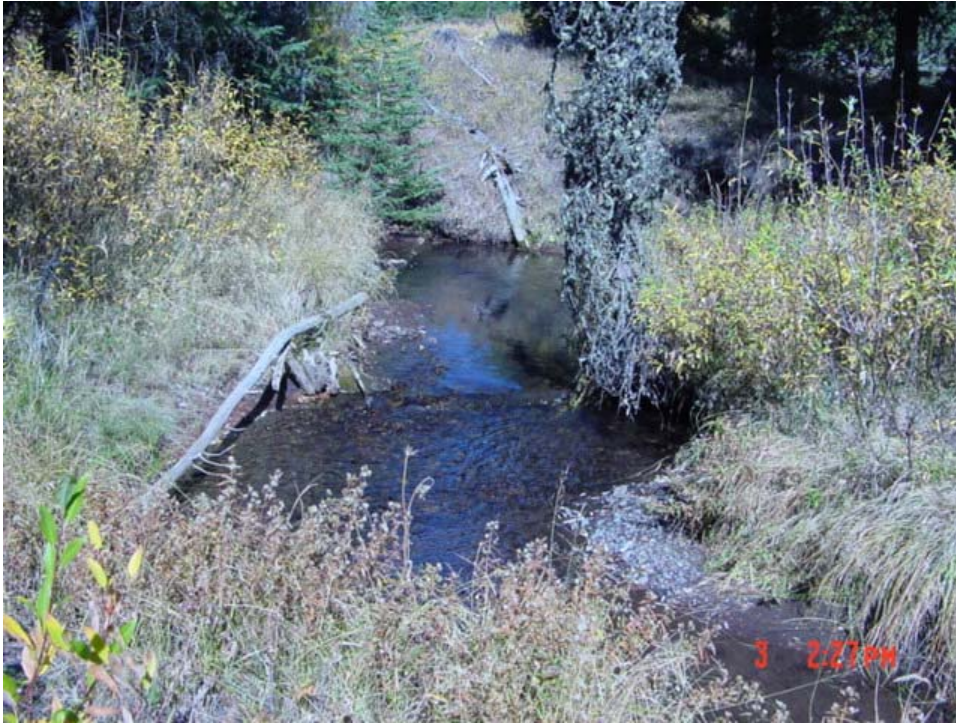
Figure 80 Hotel Creek about ½ mile below the Forest boundary. Bottom substrate is predominately sands and gravels.

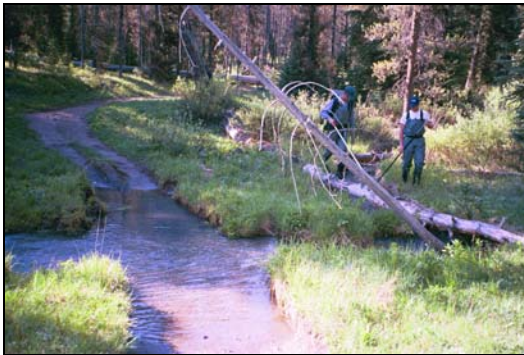
The West Fork was fishless above Arange Creek. The stream in this reach was in poorer condition. High entrenchment, turbid water, and stream captures by an old logging road indicate habitat issues on this stream. Below Arange Creek, a non-system ATV trail and crossing were reported (Figure 81).

Figure 81 ATV Crossing on Hotel Creek

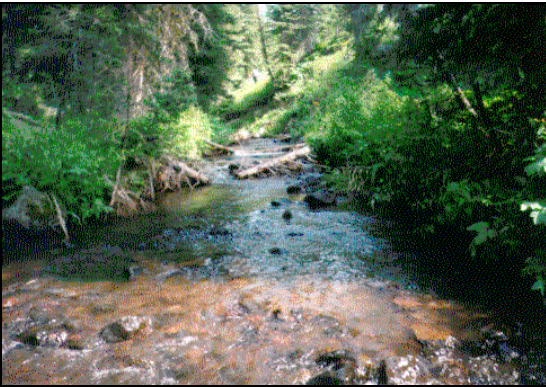
Figure 83 Yale Creek ATV crossing.

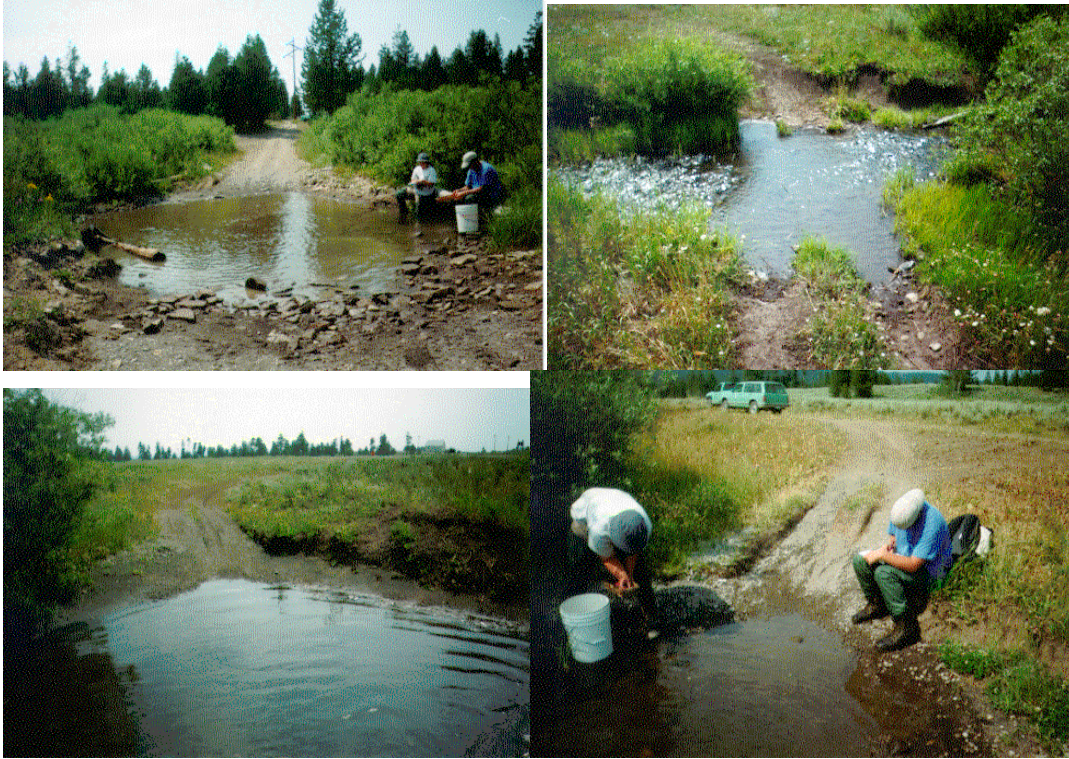
Figure 84 Three stream crossings on Mill Creek

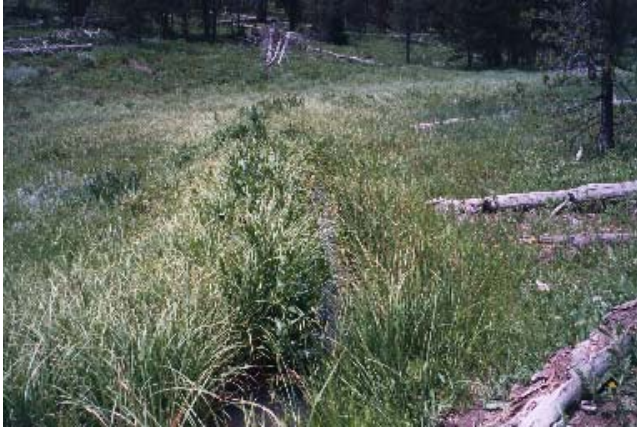
IDFG reported cutthroat and brook trout circa 1967. Forest surveys (2003) reported 86% brook and 14% rainbow trout, and sculpins. Most fish were found in the first unit sampled near the confluence with the Henrys Fork. The higher numbers of rainbow can be attributed to the influence of the Henrys Fork. No fish were found greater than a half mile from the Henrys Fork. An old jeep trail crosses the stream near the Henrys Fork and then converts into an ATV trail that follows the creek upstream for about a third of a mile where it crosses again (Figure 85). The stream appears to be a Rosgen E-type channel that is narrow and deep with a readily accessible floodplain and is shaded by a dense growth of tall carex (Figure 86).

Figure 86 Natural conditions; stream is shaded.

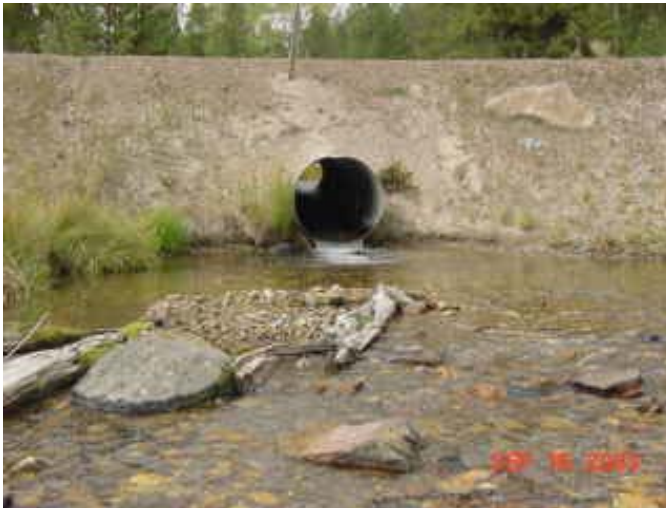
Figure 87 Downstream view of widened channel.

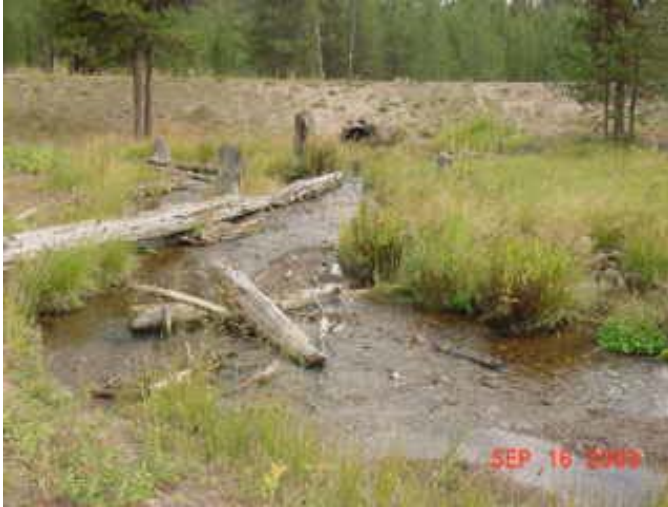
Figure 88 Upstream view of braided channel.

Visual observations suggest there is more sediment below the road than above indicating there is improper drainage on the road. Maximum water temperatures likely are on the cold side.

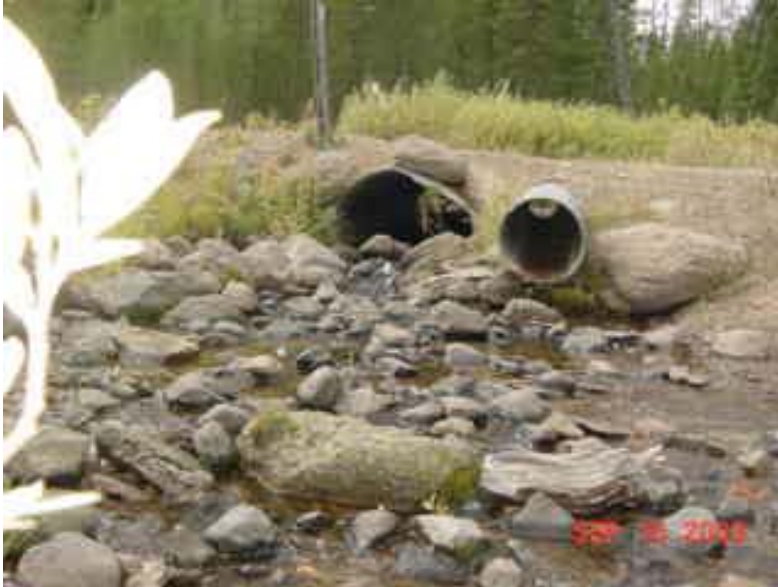
Figure 89 Downstream of culvert.

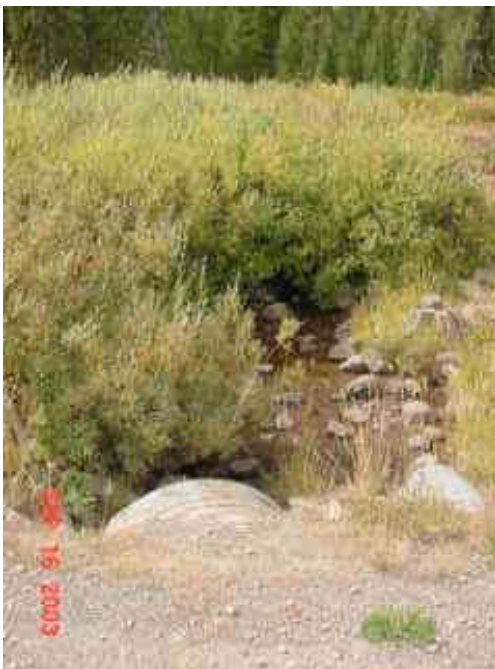
Figure 90 Upstream of culvert.

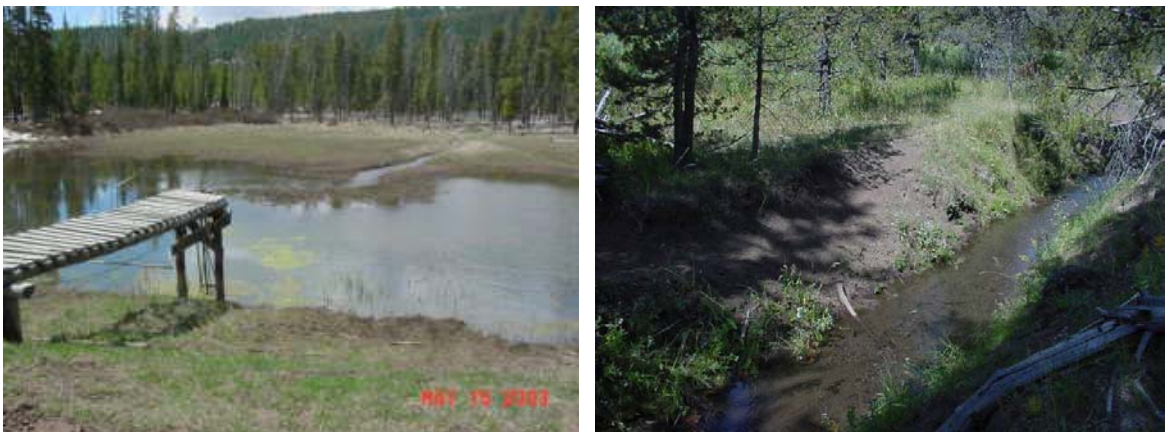
Figure 91 Left partly filled pond, Right down-cut ditch upstream of pond with cattle impacts.

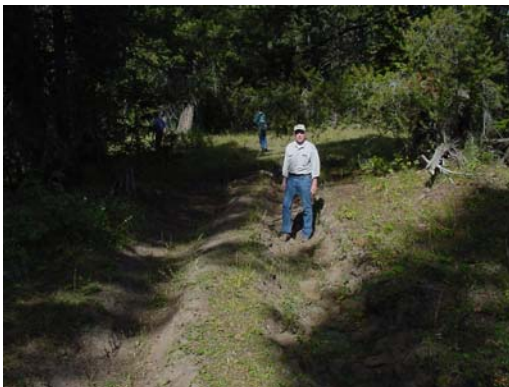
Figure 93 Ruts formed by spring stream capture on jeep trail.

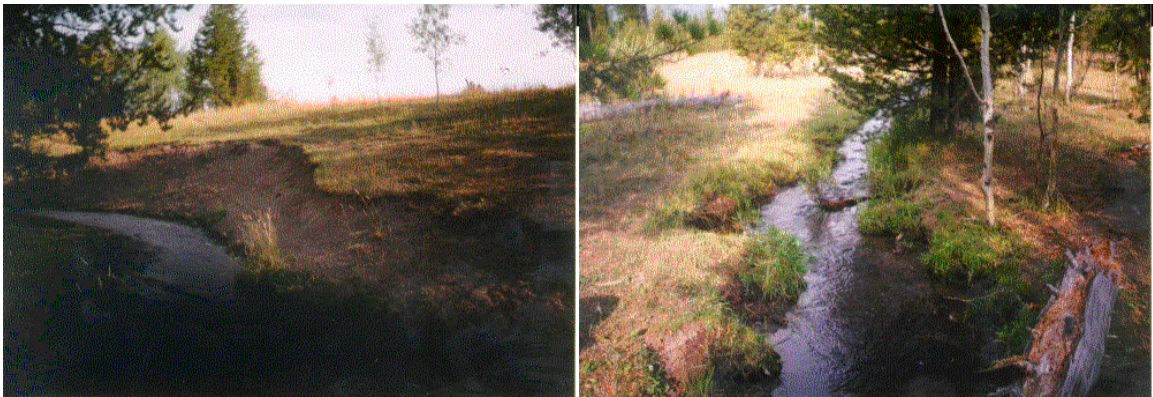
Figure 94 Left, trampling impacts; Right, moderate grazing along stream

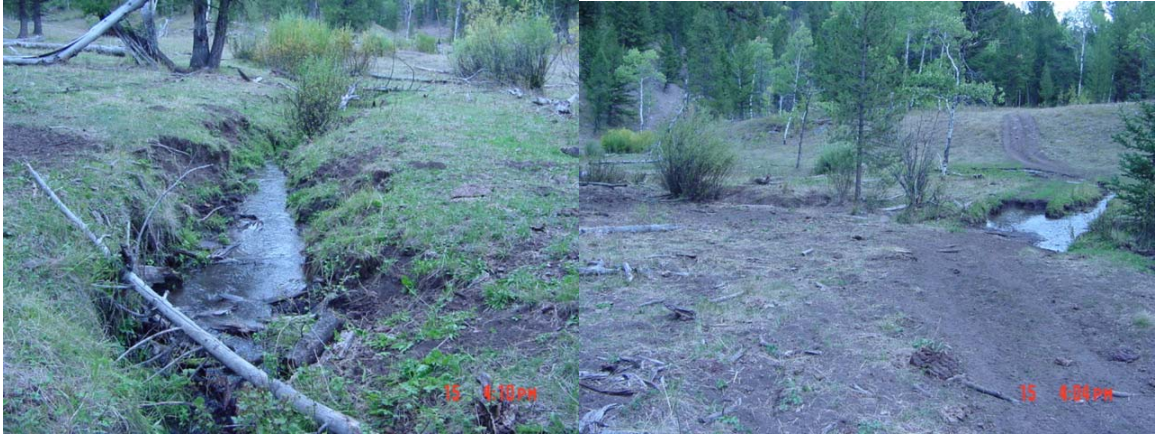
have perennial water. During these surveys no fish were found. There are several non-system roads and trails in use impacting the stream. Grazing has had moderate to severe impacts on the stream (Figure 96). There is sufficient water to provide beaver habitat up high but the forage is limited.

Figure 96 Left, down-cut with evident cattle damage; Right, non-system trails with impacts.

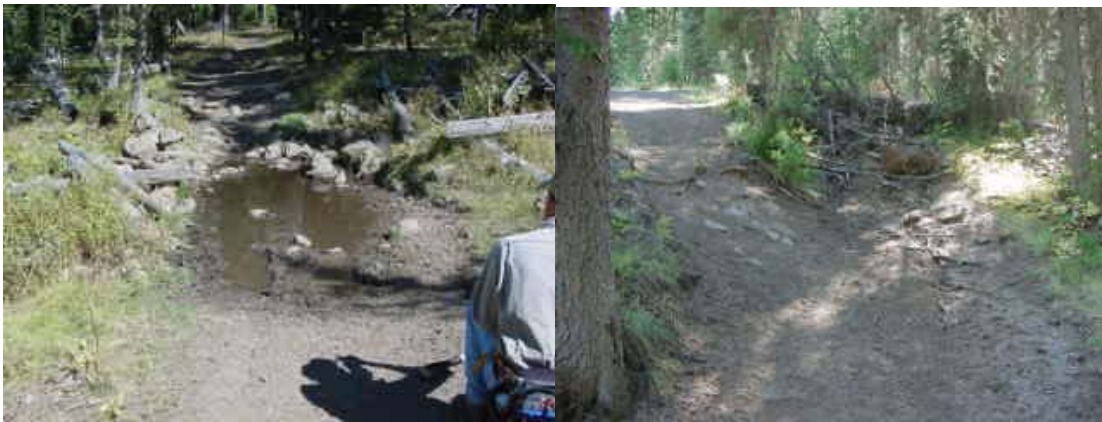
Figure 97 Non-system ATV trail.

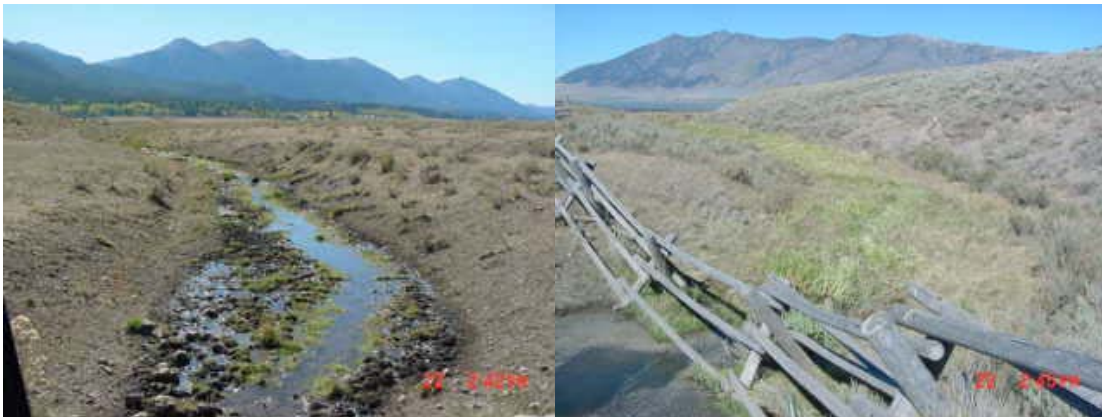
Kinney Creek lies within private and BLM ground and is the unnamed stream east of Hope Creek on the Forest map. Springs and an irrigation diversion from Hope Creek feed this stream. Forest fisheries crews did not sample this stream. It is doubtful that any game fish occur in this creek. Low flows and degraded habitats make it inhospitable for use by adfluvial cutthroat (Figure 99).

Figure 99 Kinney Creek recently acquired by BLM, Kinney Ck. downstream of previous on BLM land exclosure.

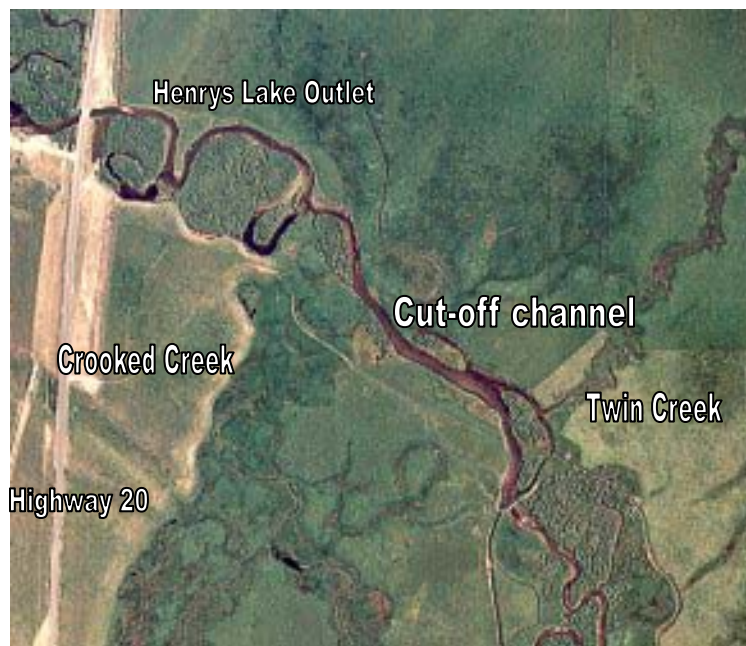
Crooked Creek is approximately 4.5 miles in length and occurs only on private lands. The lower reaches near the confluence with the Outlet likely contain fish. It may have had its origination as the original channel from the Henrys lake Outlet, before enlargement of Henrys Lake and the use of the stream channel as a conduit for high irrigation flows, it also picked up additional water from springs in the area. It appears from aerial photos that after the dam was built a channel was cut connecting the Outlet directly to the channel created by Twin Creek (Figure 101).

Figure 101 1995 Aerial photo showing suspected cut-off channel.

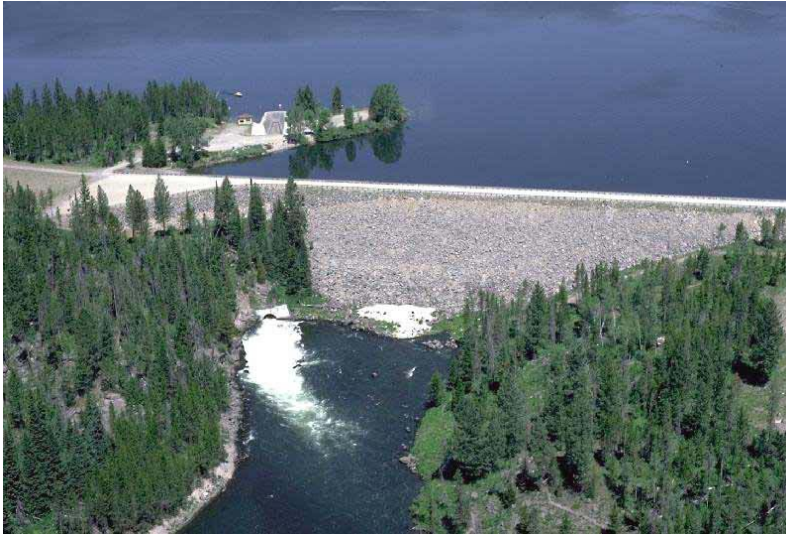
Island Park Reservoir was constructed between 1935-1938 on the Henrys Fork River storing water from a drainage basin of 482 square miles. It is an earthen dam 91 feet in height with a storage capacity of 135,205 acre-feet (Figure 105). It is a popular fishing and recreation reservoir, however its main purpose is to provide irrigation water to the Fremont Madison Irrigation District. During drought years, it is nearly emptied and the fishery suffers. In 1994, a hydroelectric plant was added to the dam. The inlet to the hydro facility is screened but other outlets remain unscreened. When water drops below a certain level, power can no longer be generated and all water entering the Henrys Fork is unscreened and can transport large numbers of fish. The reservoir has been highly managed and has had a great influence on the fishery.

Figure 105 Island Park Dam and Reservoir (Courtesy of USBR).

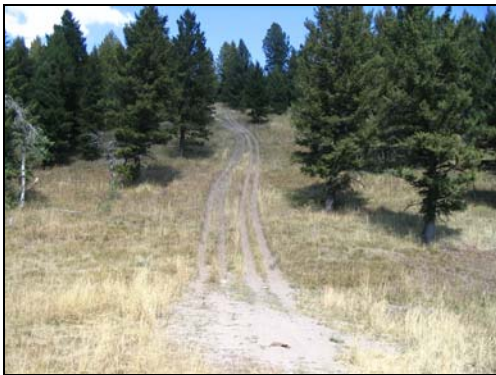
The advancement of technology in motorized recreation vehicles has allowed users to access areas within the watershed that they were unable to access in the past. Many open areas, such as meadows, are used extensively by snowmobilers. Use of ATV's has also increased dramatically, and non-system trails have become a resource concern (Figure 109, Figure 110).

Figure 110 Resource damage from illegal ATV use in the Bootjack area.
